## Survey Report Mortuary Chapel, Queen's Road, Fakenham, Norfolk

1<sup>st</sup> August 2023

Fakenham Town Council

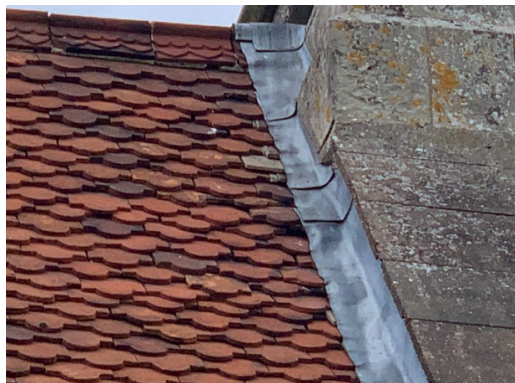
The roof is covered with red clay plain club tiles. The south side has recently had some units replaced, but some of the originals are delaminating or have surface wear. Some are slipping, especially on the north side. The roof appears to be nail sick.

The lead flashings at each abutment are poorly dressed on top of the tiles, there do not appear to be any soakers. The sheets are too long, and the laps do not appear to be adequate.

*Chapel Roof, south east, poor lead flashing and slipping tiles at abutment*

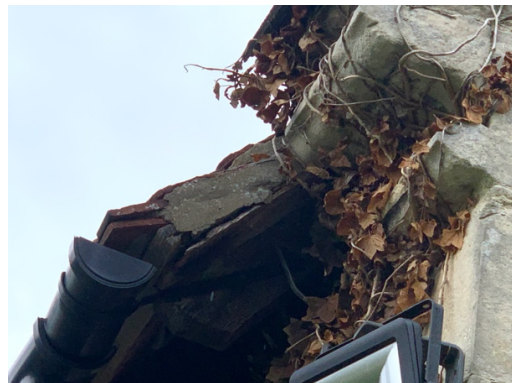
The undercloak on the small piece of verge on the south east side appears to be missing, and has been filled with cement mortar, which is loose and cracking.

South east corner, showing poorly detailed verge

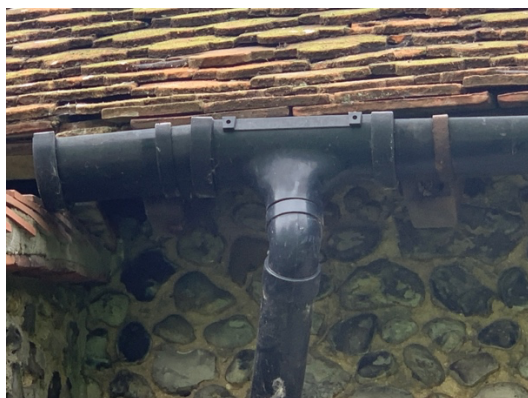
*Poorly aligned PVCu gutters, north side*

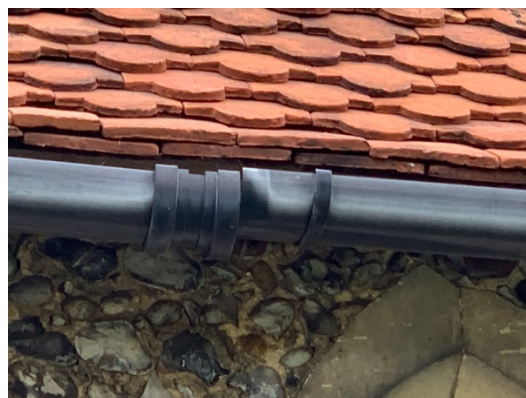
*Joint failed, south side*

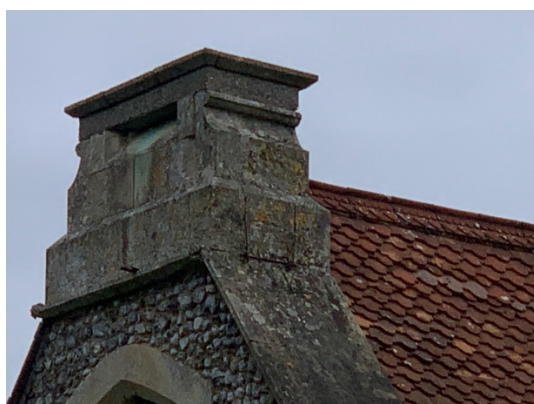
The bellcote has a missing top and no bell. There is water penetration through it, which is tracking through the wall and onto the soffit between the two buttresses and down through the top of the window. There are some open joints in the stone masonry.

*Bellcote, showing concrete copings, and missing top. Tiles to right of picture are slipping*

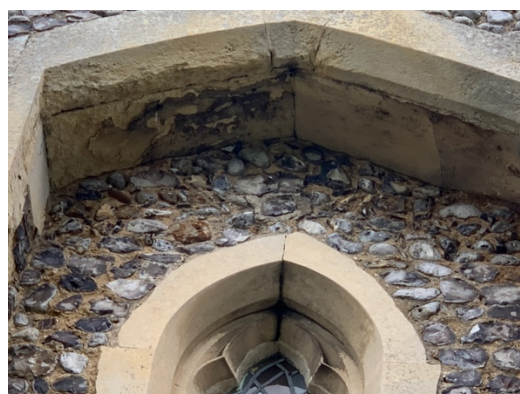
*Water penetration through soffit of bellcote and top of E1.*

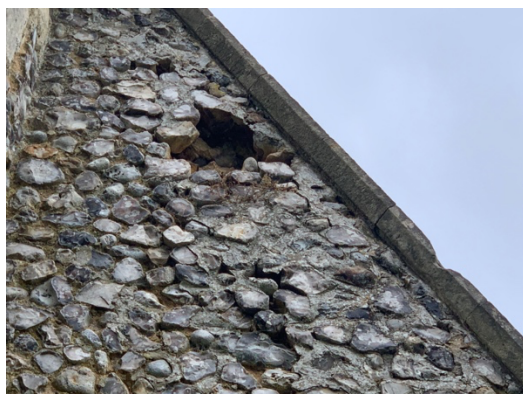
*Loose and missing facings, east wall*

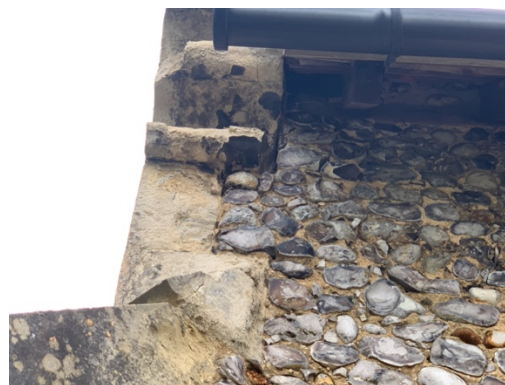
The south west and north west corners have badly eroded quoins and kneeler stones.

*Eroded kneeler and quoins, south west corner*

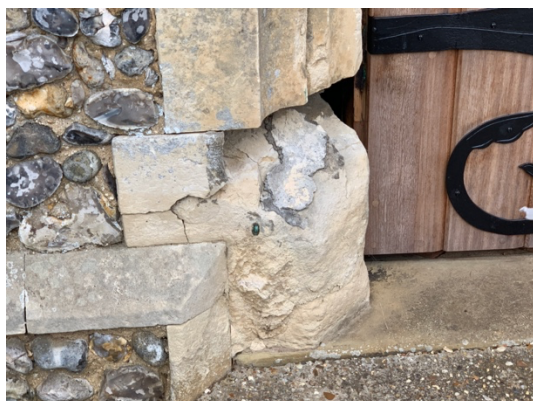
D1 is the main entrance. There is a badly damaged stone at low level on the west side, possibly due to rust jacking from the pintle hinge. The door leaf has been refaced in oak recently, and the ironworks refurbished.

*Damaged reveal to D1 due to rust jacking*

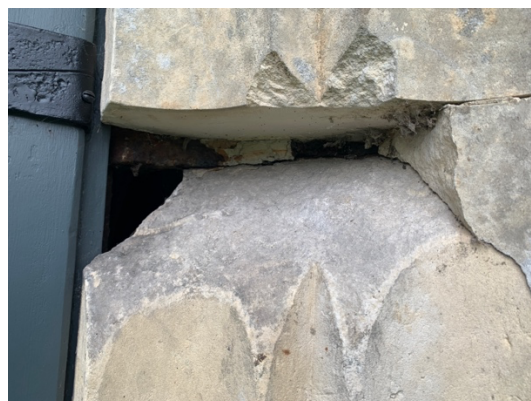
D2 is not used. There is a badly damaged stone due to rust jacking from the pintle. The door is in danger of coming loose. The door has had the planks cut back at low level and replaced with a single board and repainted. The planks have areas of rot at the joints, and gaps in some places.

*Rust jacking, D2, leaving a hole to the interior and an exposed pintle hinge.*

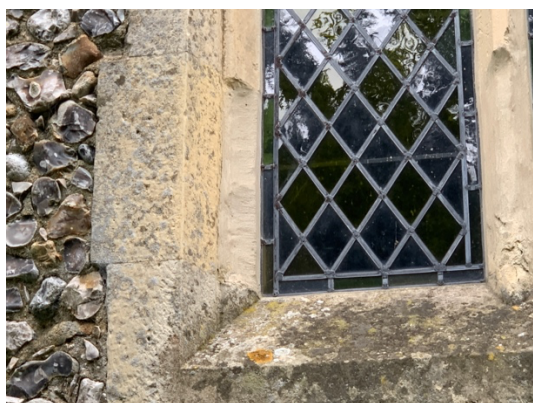
W1 is a two light window at high level. It has had plastic repairs to the mullions and reveals, which are badly matched in colour and are too small in shape to support the stone above. There is some slight damage to the tracery.

*Poor plastic repairs, W1*

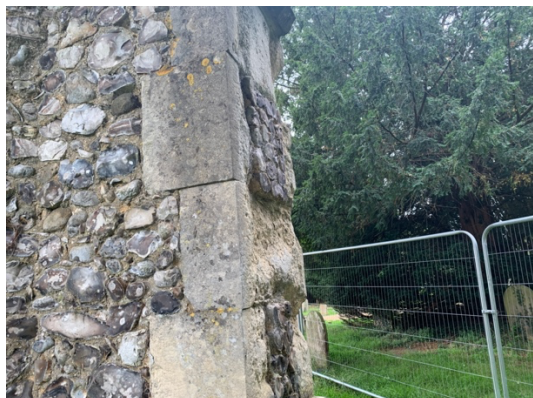
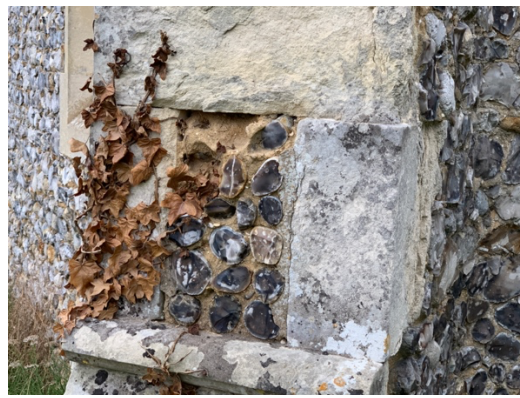
B2 has damaged stone quoins and poorly executed and unsuitable repairs. The flints on the top stage on the north east side are hollow; coming loose.

*B2, showing erosion and exposed edges of flushwork*

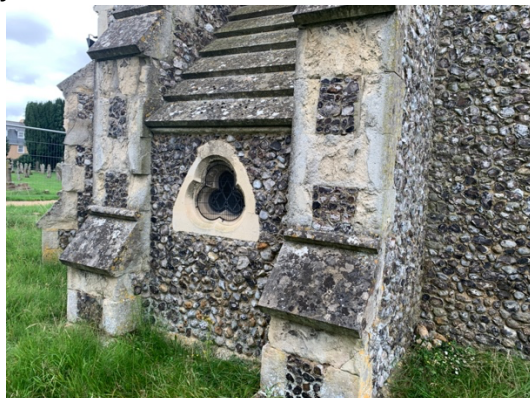
B4 and B5 support the overhanging bellcote. Both have badly eroded quoins.

*Erosion, B4 and B5. Cupboard roof*

*B6, missing flushwork and damaged stone*

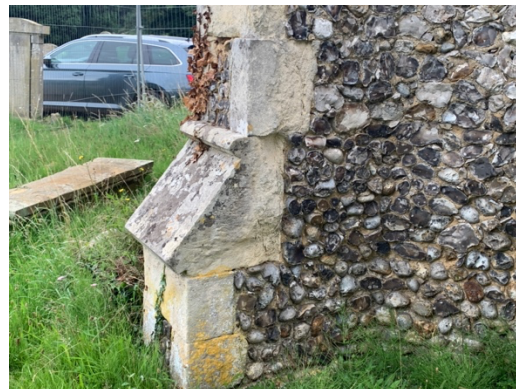
*High soil levels covering plinth, B6.*

B6 has badly eroded quoins, and missing flushwork as a result.

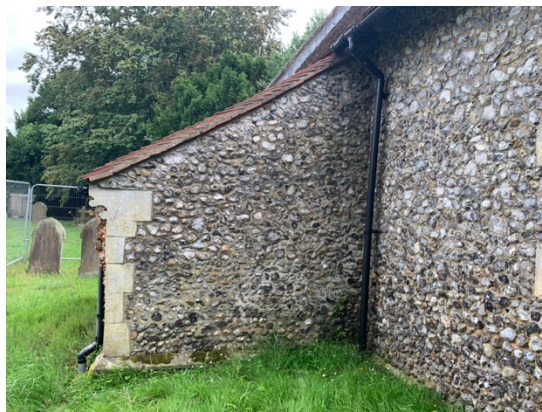
*Damp in corner of Vestry*

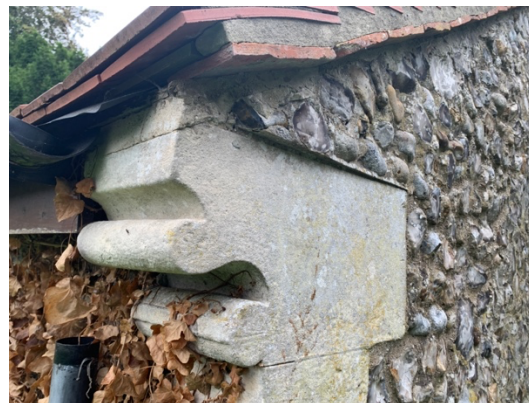
The flint facings on the west side are becoming detached at high level. There have been some poorly done cement mortar repairs. There is some slight movement in the quoins on the north west corner. There is a damp patch at low level on the west side where it adjoins the chapel, due to poor rainwater goods. There is moss growth and damp on the plinth.

*Misaligned flint facings, west side of Vestry*

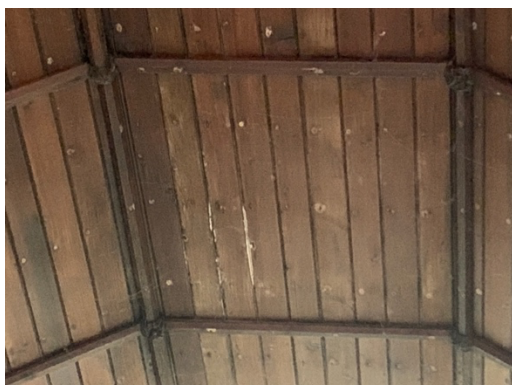
The ceiling soffit is lined with softwood boards. They are extensively stained at all the nail positions. There is staining on the flat section, second bay from the east, and what appears to be rot on the edges of the boards. There are water marks elsewhere, from leaks, and/ or condensation.

*Ceiling, showing stains around nails and between boards*

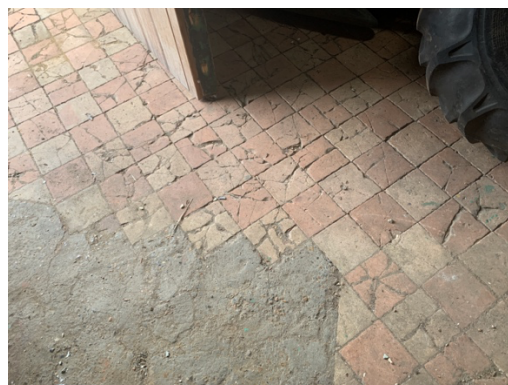
Mainly obscured by stored items. It is of red and cream quarry tiles, extensively cracked at the west end. There is a dip in the floor to the north west.

There are some patches of a cement based screed where the tiles are missing.

*Damaged floor tiles and cement screed patch*

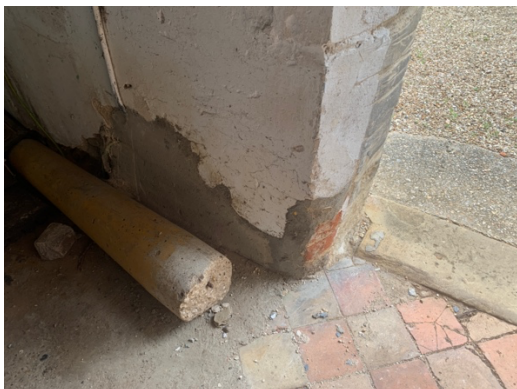
The walls are plastered. The bottoms of the walls were generally obscured by stored items. There is some damage at low level to the east of D1, and a cement render patch. The reveals of D1 are damaged at low level.

*Damaged plaster and cement repair, D1*

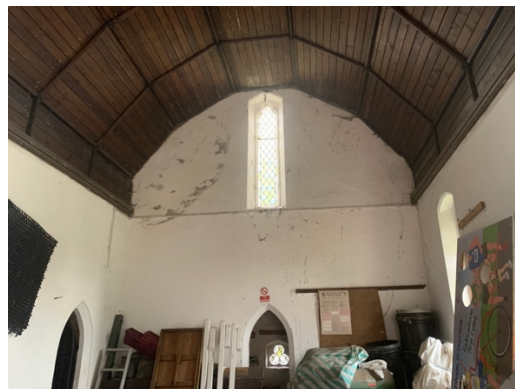
*Damp at high level, north west side*

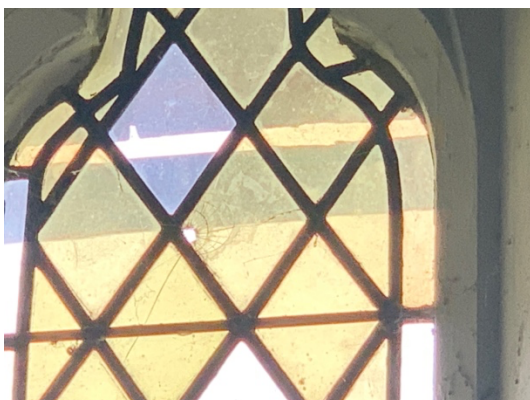
There are three cracked quarries in window S3, two in S2 and a stone hole and crack in S1.

*Hole in glazing of window S1*

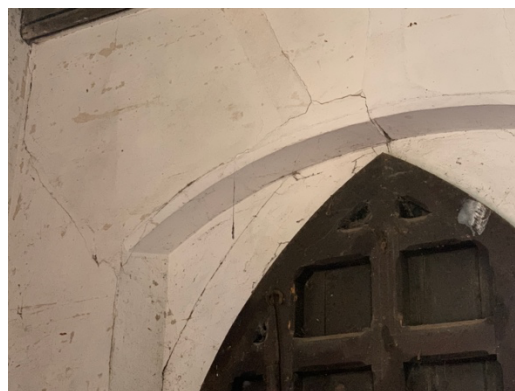
There is a crack under W1 south side, and another crack above at high level on the north side. There is a further crack down the south west corner, cracks over D2 and in the apex of N1. These do not appear to be significant but must be monitored.

*Plaster cracks over D2*

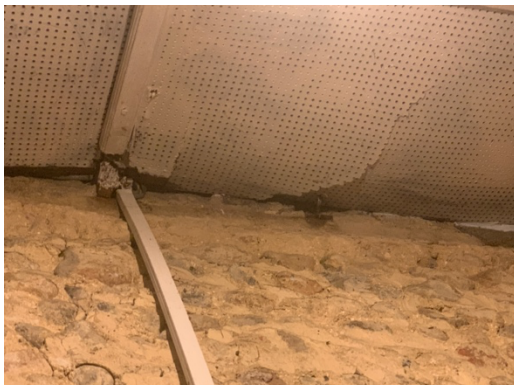
Partly lined with pegboard, which is deteriorating, especially at the junction with the chapel wall.

*Damaged ceiling lining, Vestry*

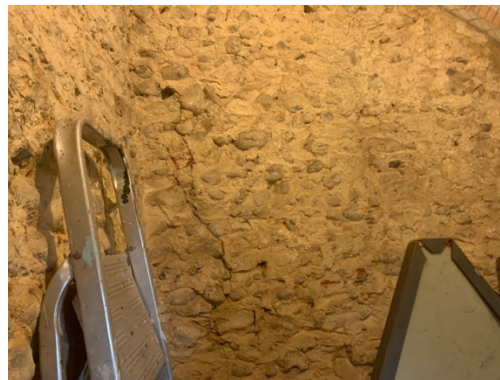
There is a crack on the west side, near the junction with the chapel.

*Cracks in west wall*

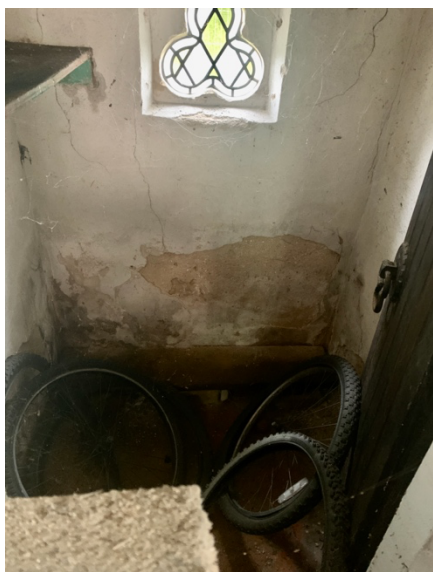
*Damp damaged plaster, cupboard*
